COMPOSITE FAILURE ANALYSIS HANDBOOK  
VOL I - PROGRAM OVERVIEW

R.J. Kar  
Northrop Corporation  
One Northrop Avenue  
Hawthorne, California 90250-3277

February 1992

Final Report for Period January 1987 - October 1990

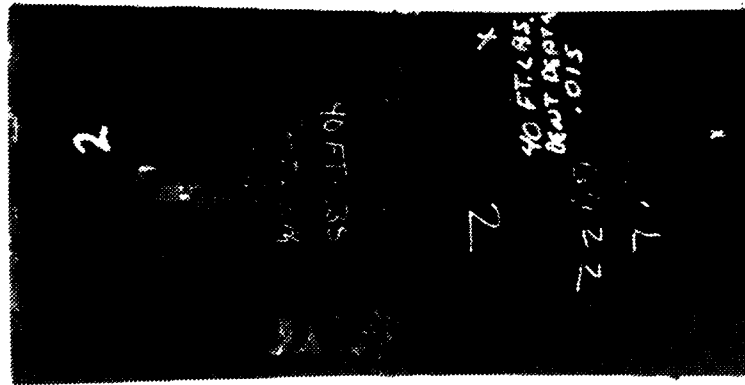
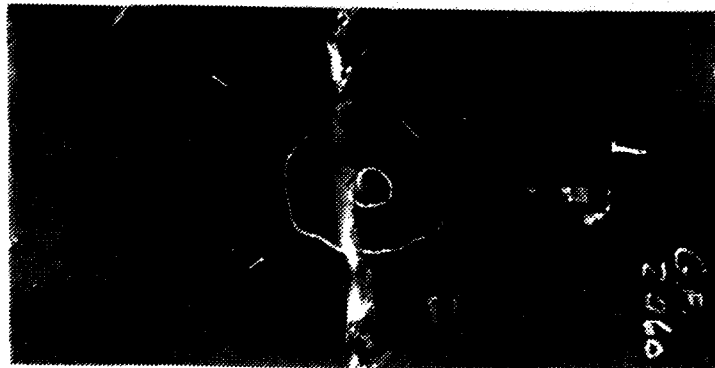
**Figure 3-70. Photographs of 48-Ply AS4/3501-6 Gr/Ep Impacted With a Force of 40 ft-lbs and PIC Tested**  
**(a) As-Tested Specimen**  
**(b) A-Scan Showing Impact Damage**

Figure 3-70. (Continued)  
 (c) Mating Fracture Halves Showing Impact (I) and Compression (C) Failure Regions

Figures 3-67 through 3-70 show photographs of fracture in Gr/Ep and Gr/PEEK that were impact damaged and subsequently PIC tested. Evaluation of the 16-ply Gr/Ep specimen indicated that the compression failure was unrelated to the impact damage (Figure 3-67). It is believed that this was a consequence of the PIC specimen being too thin (16-ply). In the thicker specimens, macroscopic compression failure initiated in the zones of delamination caused by impact (Figures 3-68 through 3-70).

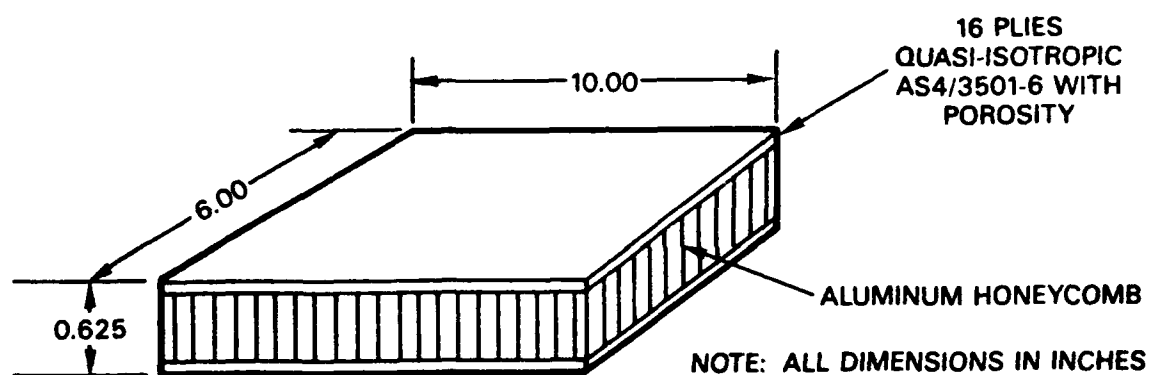
**Figure 3-75. Gr/Ep-Al Honeycomb Structure**  
 (a) Schematic Diagram  
 (b) Photograph of As-Fabricated Part

Figures 3-75a and 3-75b show a schematic diagram of the Gr/Ep-Al honeycomb structure, and a photograph of the fabricated part. The specimen (6 inches x 10 inches x 0.625 inches) consisted of two AS4/3501-6 Gr/Ep skins (16-ply, quasi-isotropic 0-, 45-, and 90-degree ply orientations), that contained porosity. Porosity was introduced in the skins by loss of cure pressure during processing. The skins were then secondarily bonded to 5052 Al honeycomb using FM-300 adhesive as per Northrop Process Specification MA 133 (Reference 13).

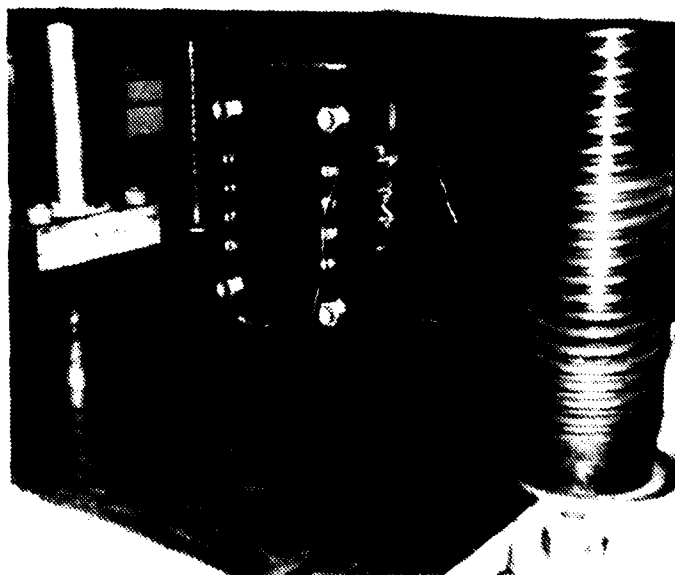
*Figure 3-77. Photograph of PIC Test on Gr/Ep-Al Honeycomb*

The honeycomb structure was subsequently failure tested under post-impact-compression loading. Figure 3-77 shows the part being failure tested. The part failed at a maximum load of 34,800 lbs, with catastrophic fracture initiating in the impact-damaged area. Subsequent loading resulted in significant drop in the load-carrying capacity of the part, with subsequent failure of the non-impacted bottom skin, and partial crushing of the core.

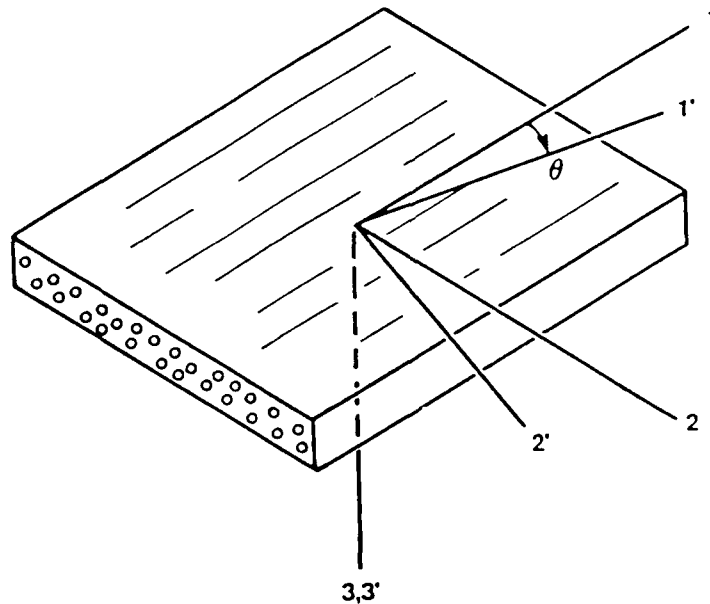
Figure A-1. Coordinate Rotation

Consider a coordinate transformation\*\* as shown in Fig. 1,

\*\* note that the coordinate transformation does not involve the out of plane direction, e.g.  $3 = 3'$
